ATELIER DEK		Realizace úspor energie - MŠ U Stadionu 602, Česká Třebová U Stadionu 602, 560 02 Česká Třebová	
projektant: DEKPROJEKT s. r. o. Tiskařská 10/257, 108 00 tel: 234 054 284 fax: 234 054 291		objednatel: Město Česká Třebová Staré náměstí 78 560 02, Česká Třebová	
stupeň dokumentace: Projektová dokumentace pro provedení stavby		část dokumentace: D.1.1. Architektonicko-stavební řešení	obsah výkresu: Detail G - nový prostup, H - stávající prostup
vypracoval: Ing. Ondřej Nečas		zodpovědný projektant: Ing. Pavel Štajnrt	
kontroloval: Ing. Petr Schindler, Ph.D. Ing. Jan Janeček		paré:	
formát: 2x A4		datum: 27. 12. 2018	č. zakázky: 2018-023009-NO
		měřítko: 1:4	číslo výkresu: D.1.1.b) 15

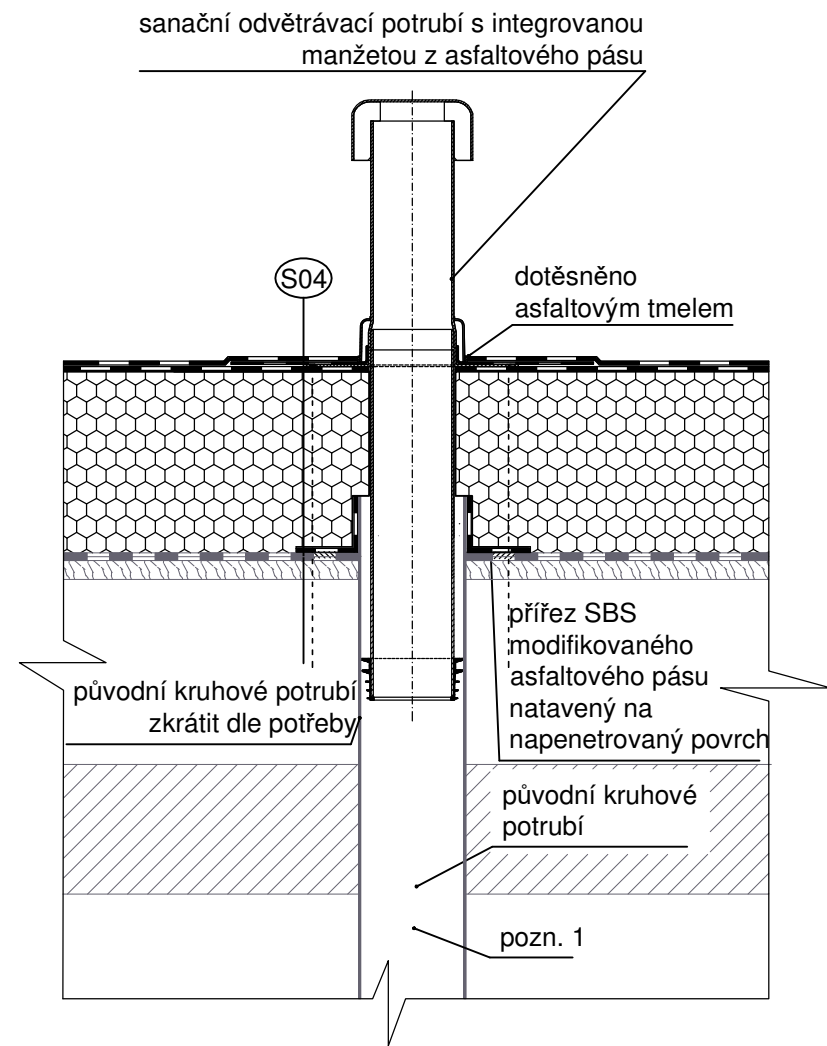
DETAIL G - NOVÝ PROSTUP

POZNÁMKA:
Details are drawn in connection with the construction S04. In the case of a different construction (e.g. fire protection strips) the penetration repair will be carried out analogously according to the principles of these details. At realization the existing state of existing penetrations will be verified. If during the execution a suitable state of the pipe is found, it can be left after agreement with the general contractor.

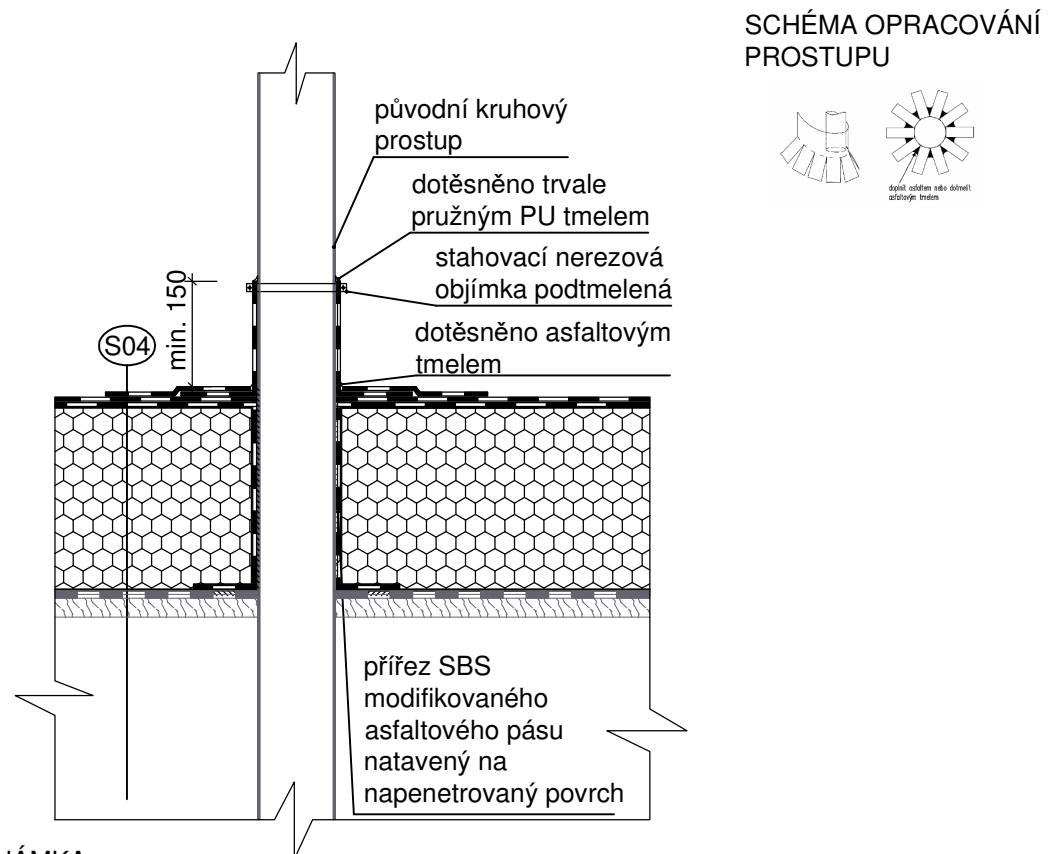
DETAIL H - STÁVAJÍCÍ PROSTUP

Pozn. 1:
It is necessary to carry out the verification of the tightness of existing penetrations at the level of the bottom layer of the roof. If necessary, carry out the sealing with PUR foam and repair the surface.
